Waukesha Cherry-Burrell Products: Votator® 4 x 120 Scraped Surface Heat Exchanger

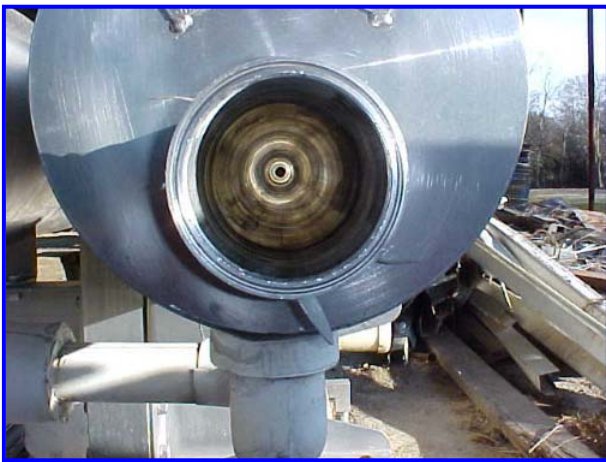
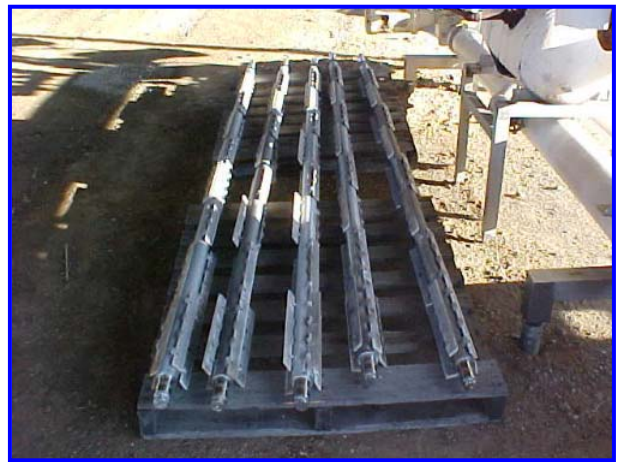
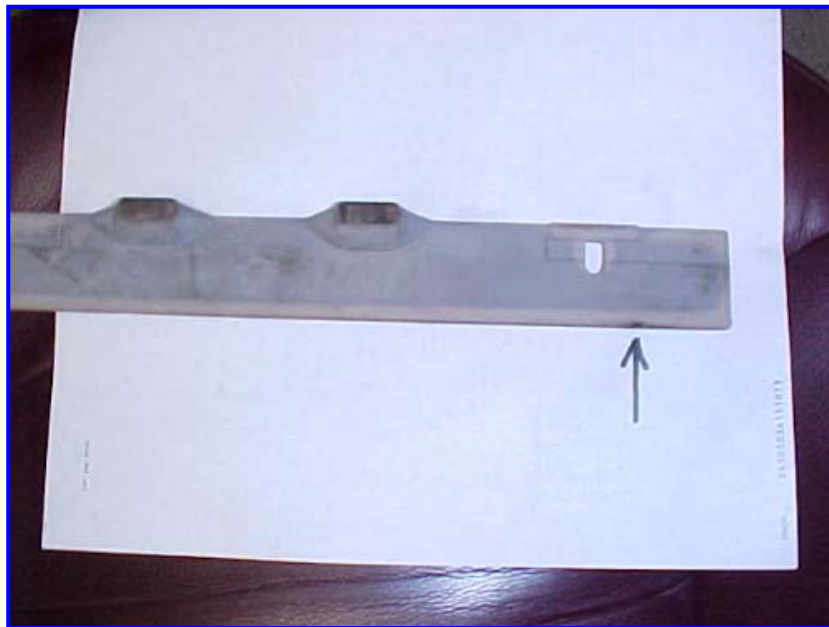
All barrels indicated normal wear patterns with no pitting, gouging or scarring. There is a hazy residue on the drive end that is easily rubbed off. All mutators are straight and complete with all blades. Clarification: The mutators have 4 rows of blades on the outlet ends only, they are two-row staggered for the rest of the length of the mutator (see photo). Blades are 13-1/2 inches long.

One abnormality was found. The lower left barrel has a raised spot of less than 1/16 inch about 5-1/2 feet from the outlet end. Our best guess is that the barrel sustained a hit from the outside, probably during original assembly or insulation. The wear pattern on the blade (see photo of blade on broken executive chair) shows the bump to be less than 1/16 inch in height and less than 1/2 inch long. The blade shows consistent contact wear along its entire length. All other blades show 100% consistent contact wear. There is no reason to believe the bump hinders heat transfer, useful life, operation or cleaning in any way but it is indeed there so we are disclosing it.
