Waukesha Cherry Burrell Glacier 600

Information Concerning Waukesha Cherry Burrell Glacier

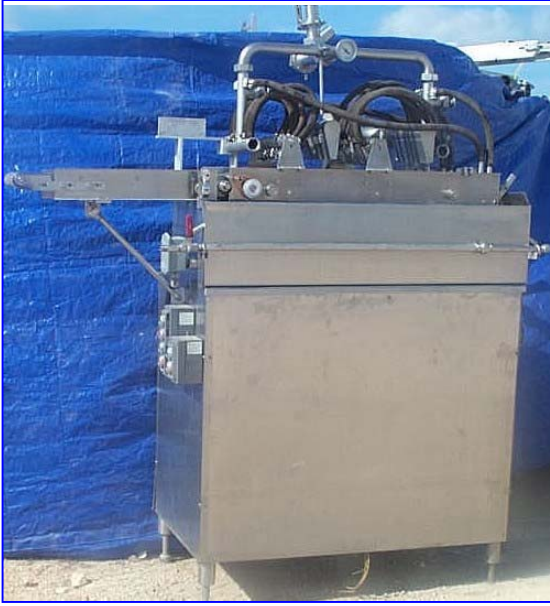
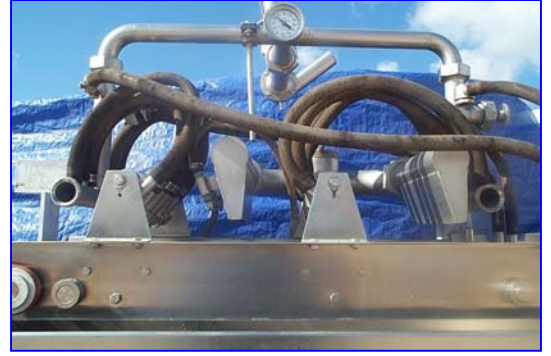
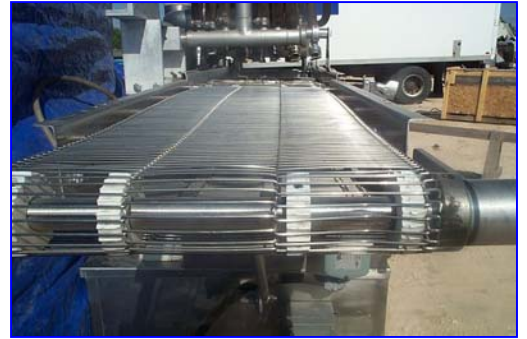
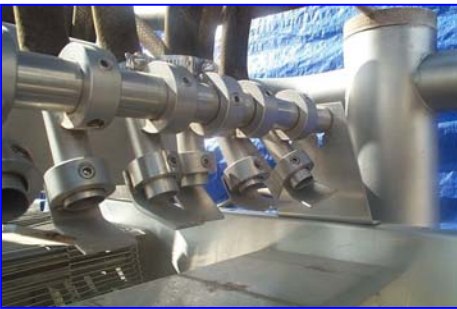
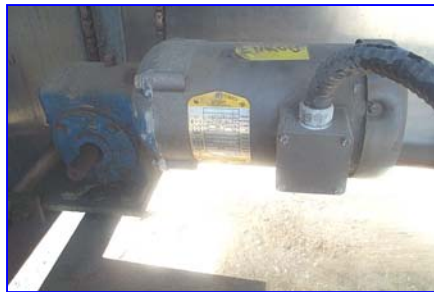
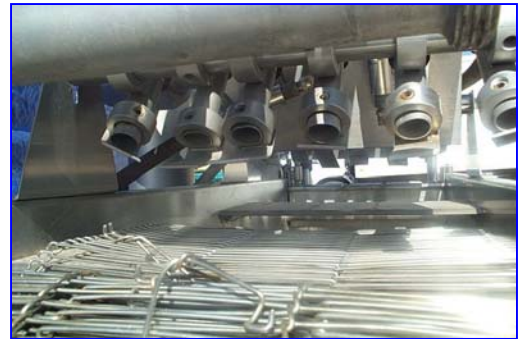
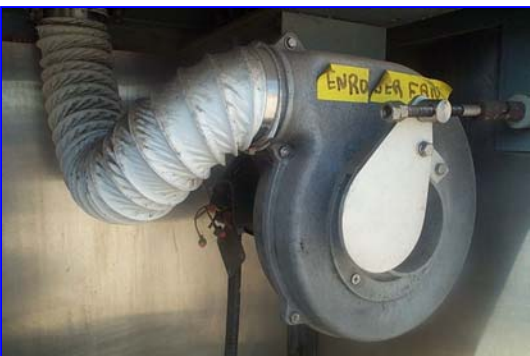
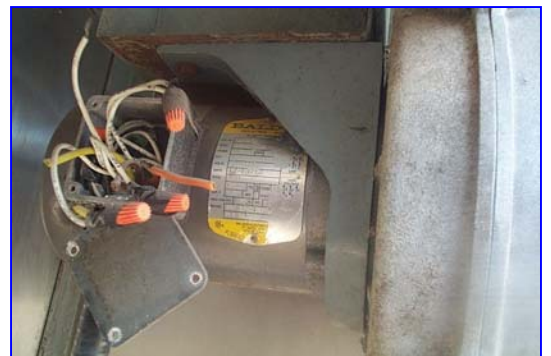
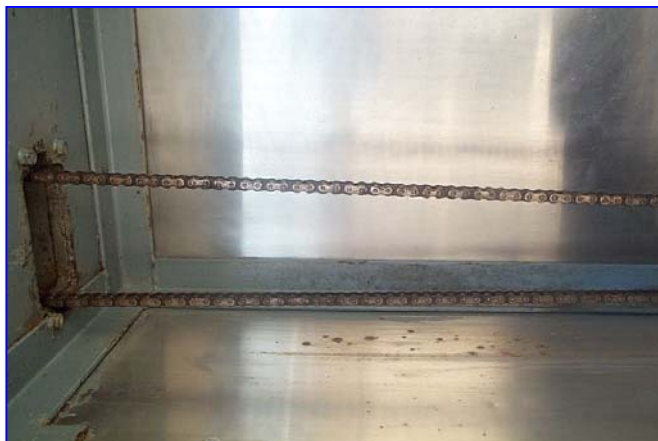
Enrober

- Entire unit was dismantled, sand blasted and repainted
- All gears, sprockets, chains and bearing replaced
- New VFD installed to replace old glacier Vari-dyne speed control
- New stainless steel top skin on unit.
- All new chain guide rails
- Cookie depositors reworked including all new pneumatic cylinders and controls, slide support
- New hot wire cutters
- New ice cream extruder horns for round cookie fabricated
- New timing chains added
- New knocking hammer and push off chain unit installed
- New transfer chain from the plates and a new corner conveyor to enrober was installed c/w new DC variable speed controls for the conveyors
